**RCRA FACILITY INVESTIGATION**  
**DU PONT EXPERIMENTAL STATION**  
**DRAFT FINAL REPORT**

**RCRA FACILITY INVESTIGATION  
DuPont EXPERIMENTAL STATION  
DRAFT FINAL REPORT**

**GeoTrans, Inc.  
46050 Manekin Plaza  
Suite 100  
Sterling, Virginia 22170**

**GeoTrans Project No. 8788-000**

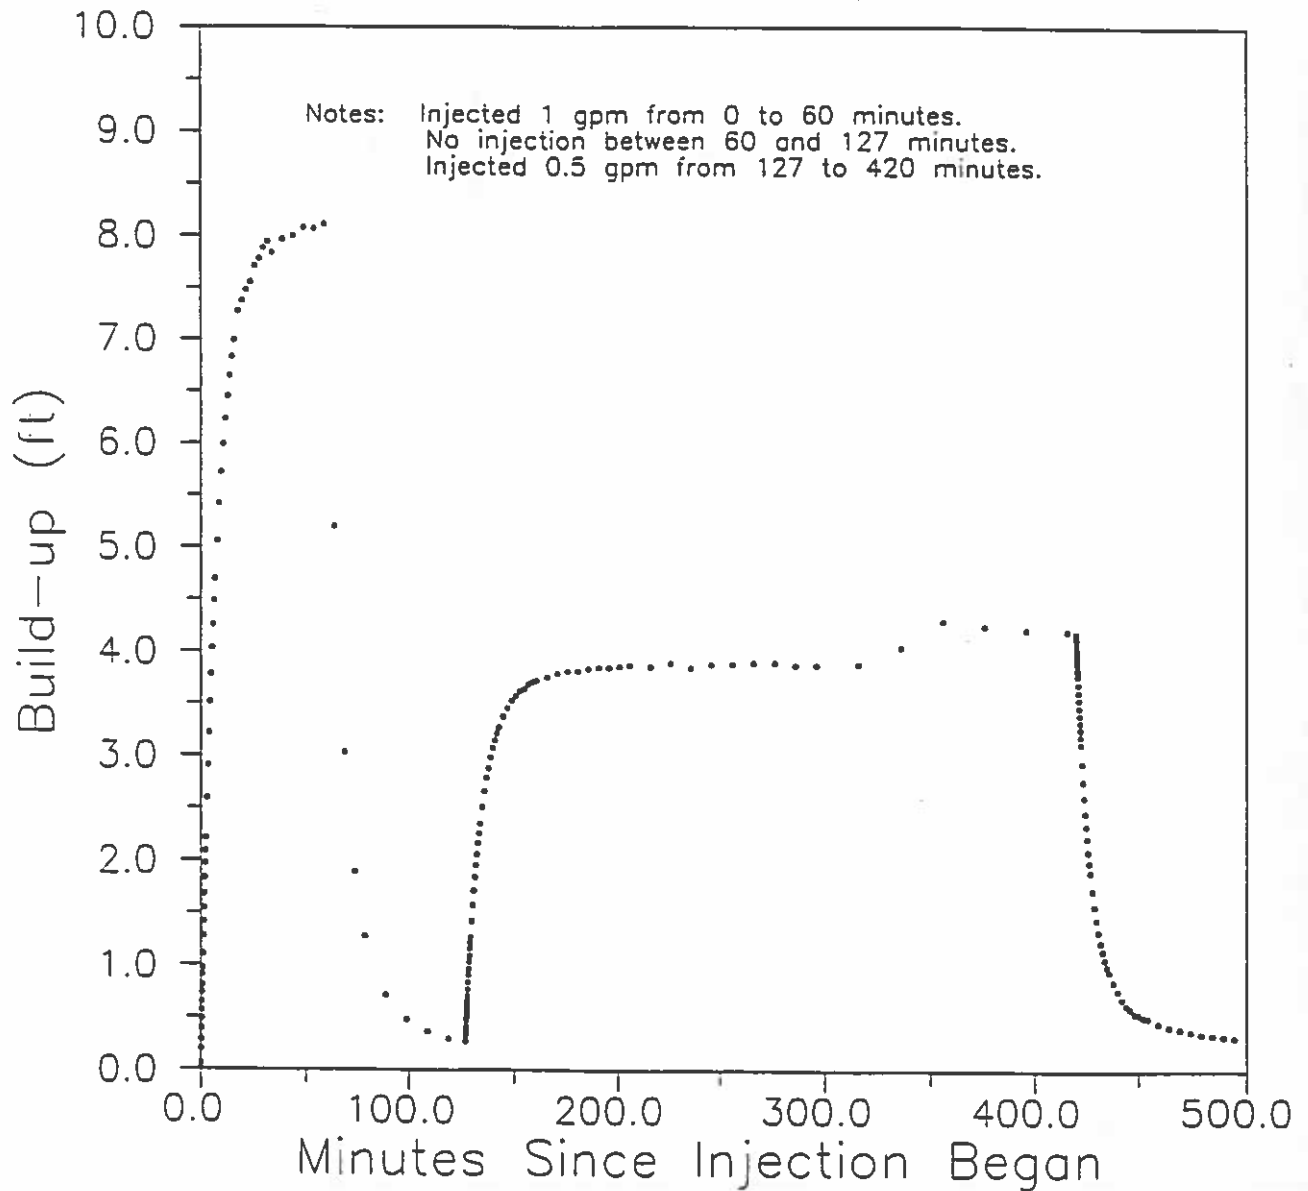
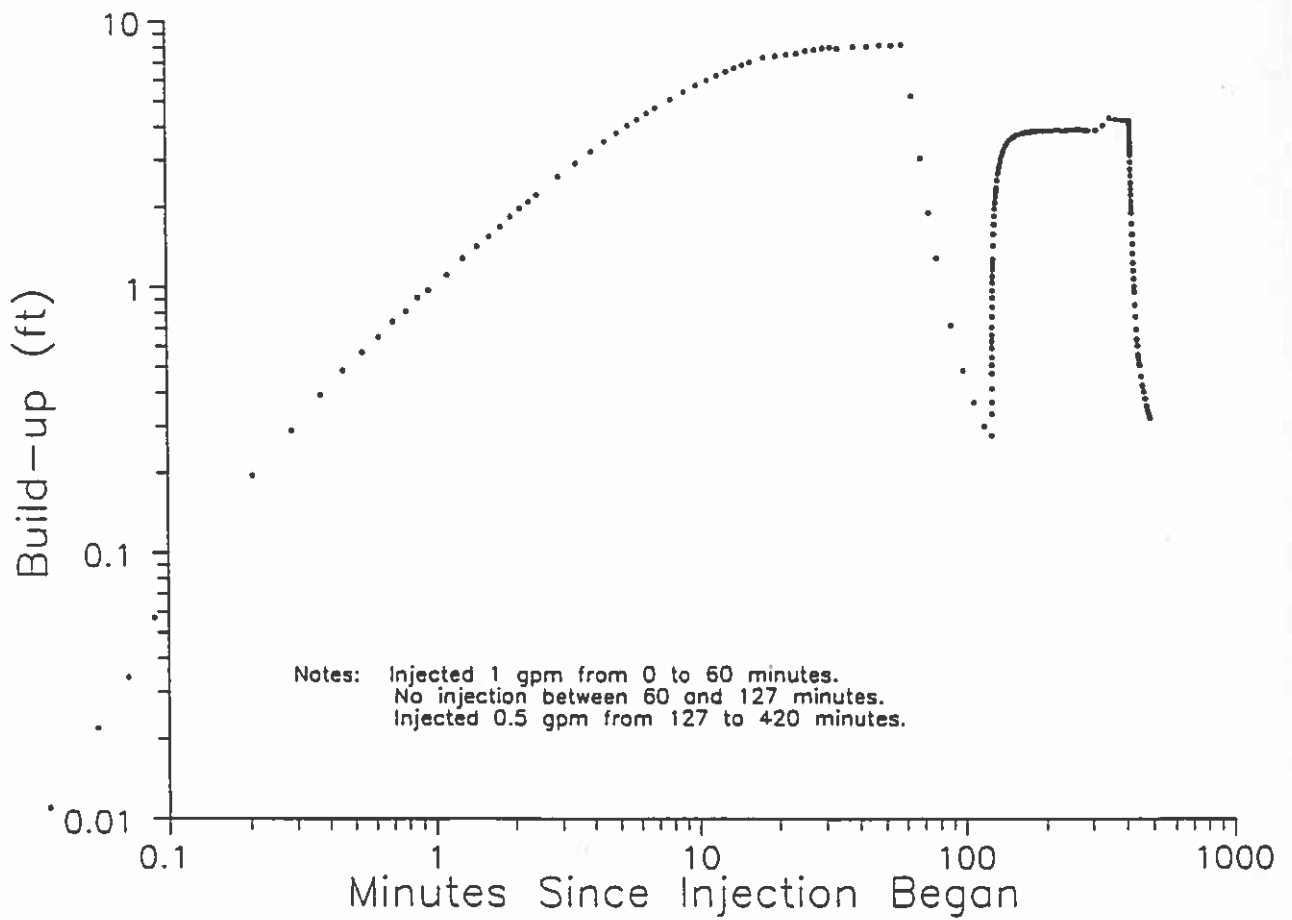
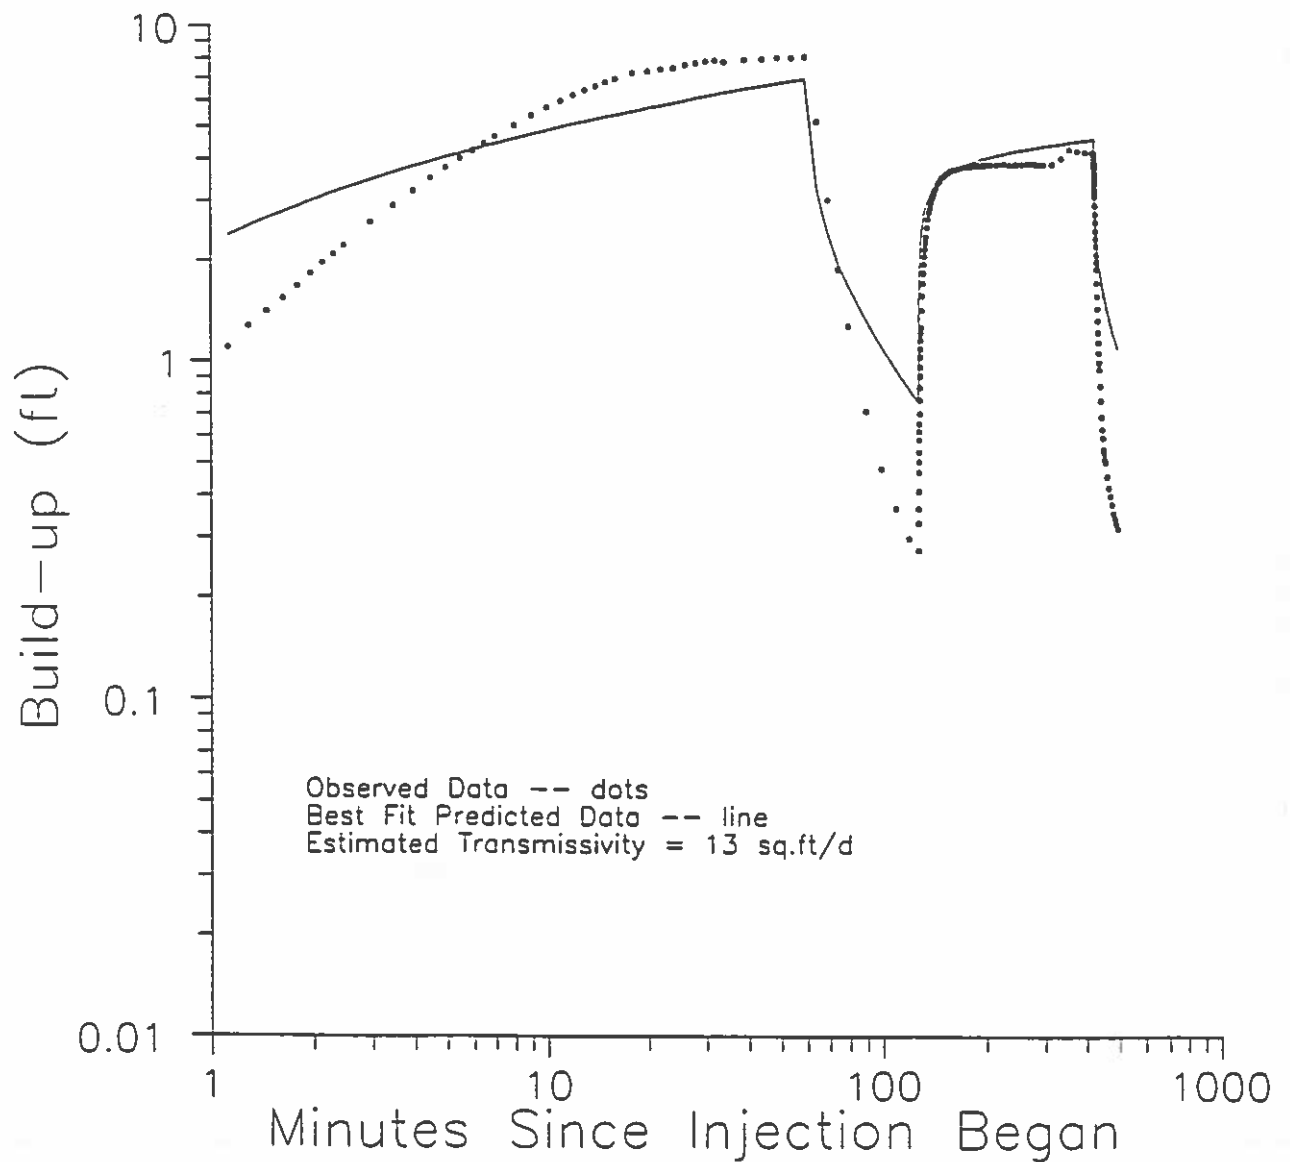
Figure 4.18a. Pumping test results at well MW-11.

THEIS BUILD-UP ANALYSIS (0-60 minutes):  
 $\text{Transmissivity} = (Q \cdot W_u) / (4 \cdot \pi \cdot s) = 5.1 \text{ sq.ft/d}$   
 where  $Q = 1 \text{ gpm}$ ,  $W_u = 1$ , and  $s = 3 \text{ ft}$ .

Figure 4.18b. Pumping test results at well MW-11.

Figure 4.18c. Pumping test results at well MW-11.

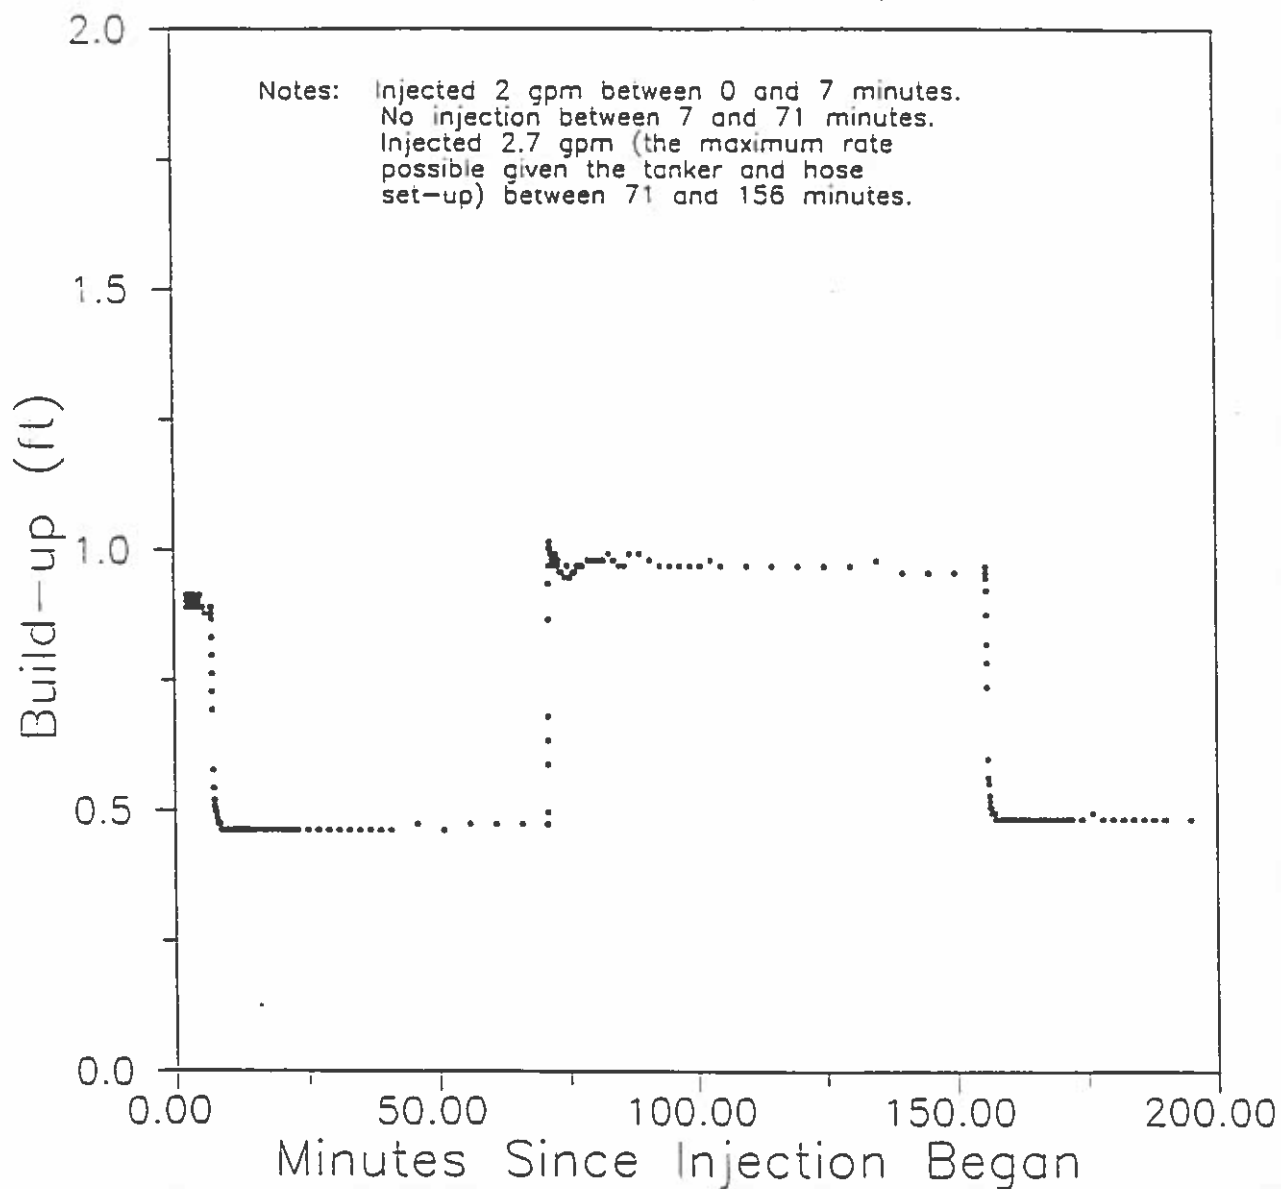
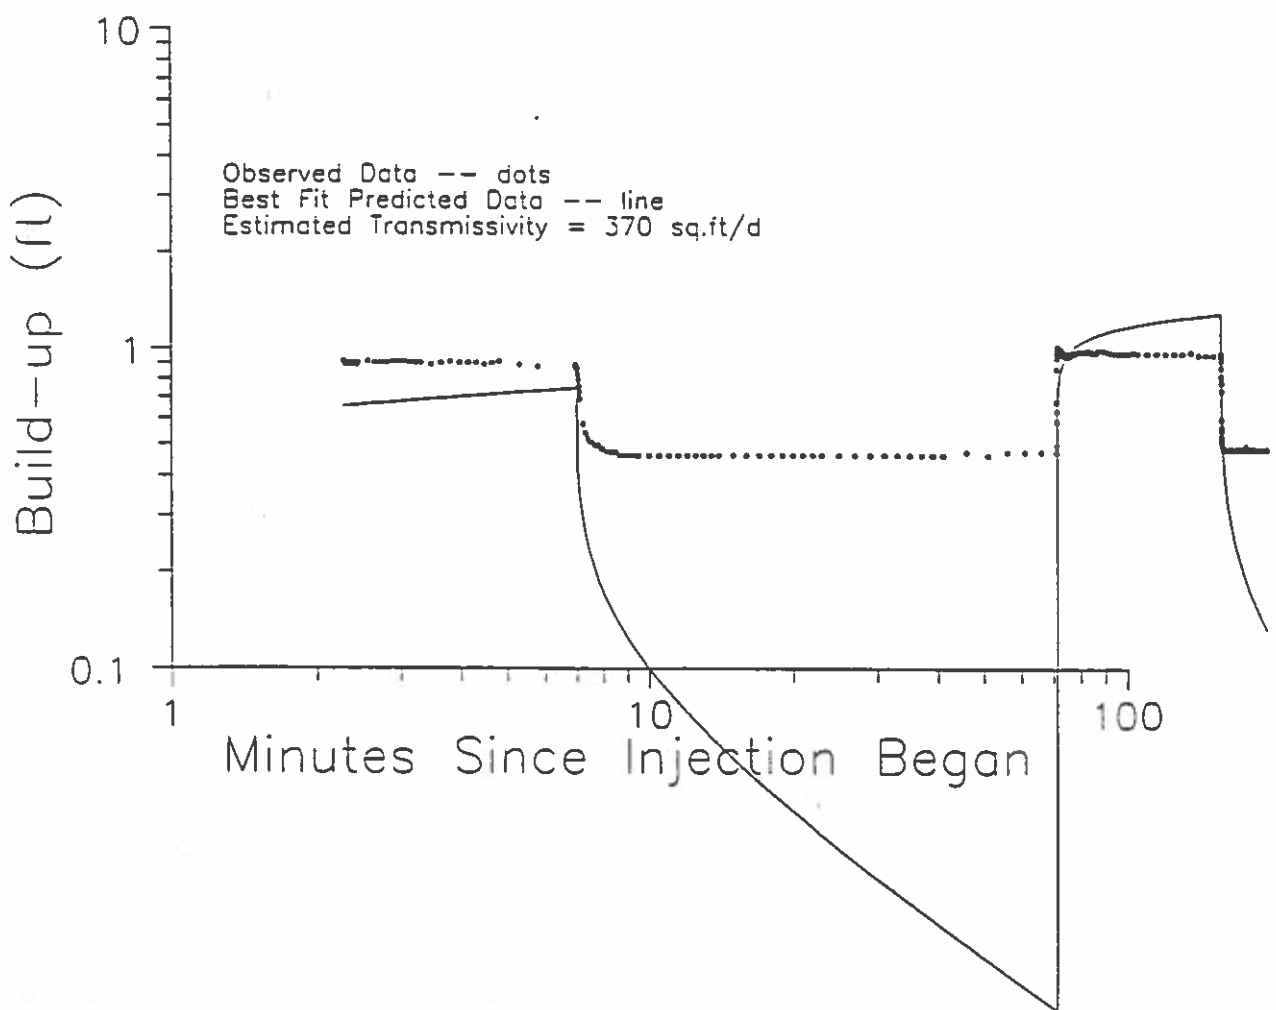
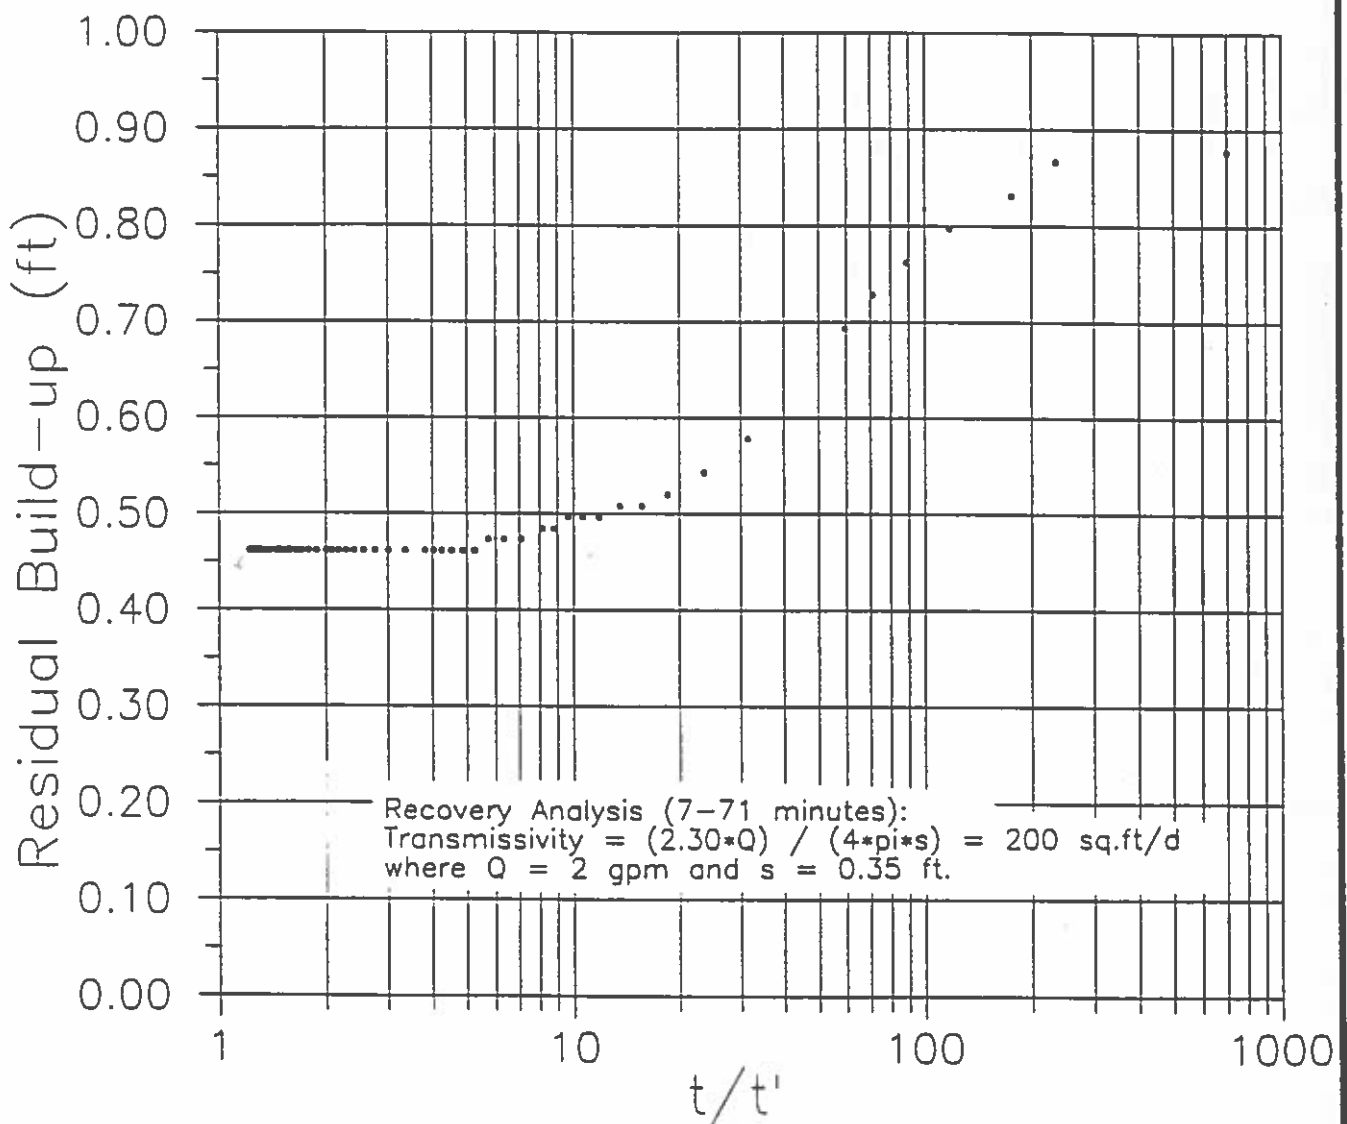
Figure 4.19a. Pumping test results at well MW-9.

Figure 4.19b. Pumping test results at well MW-9.

Figure 4.19c. Pumping test results at well MW-9.

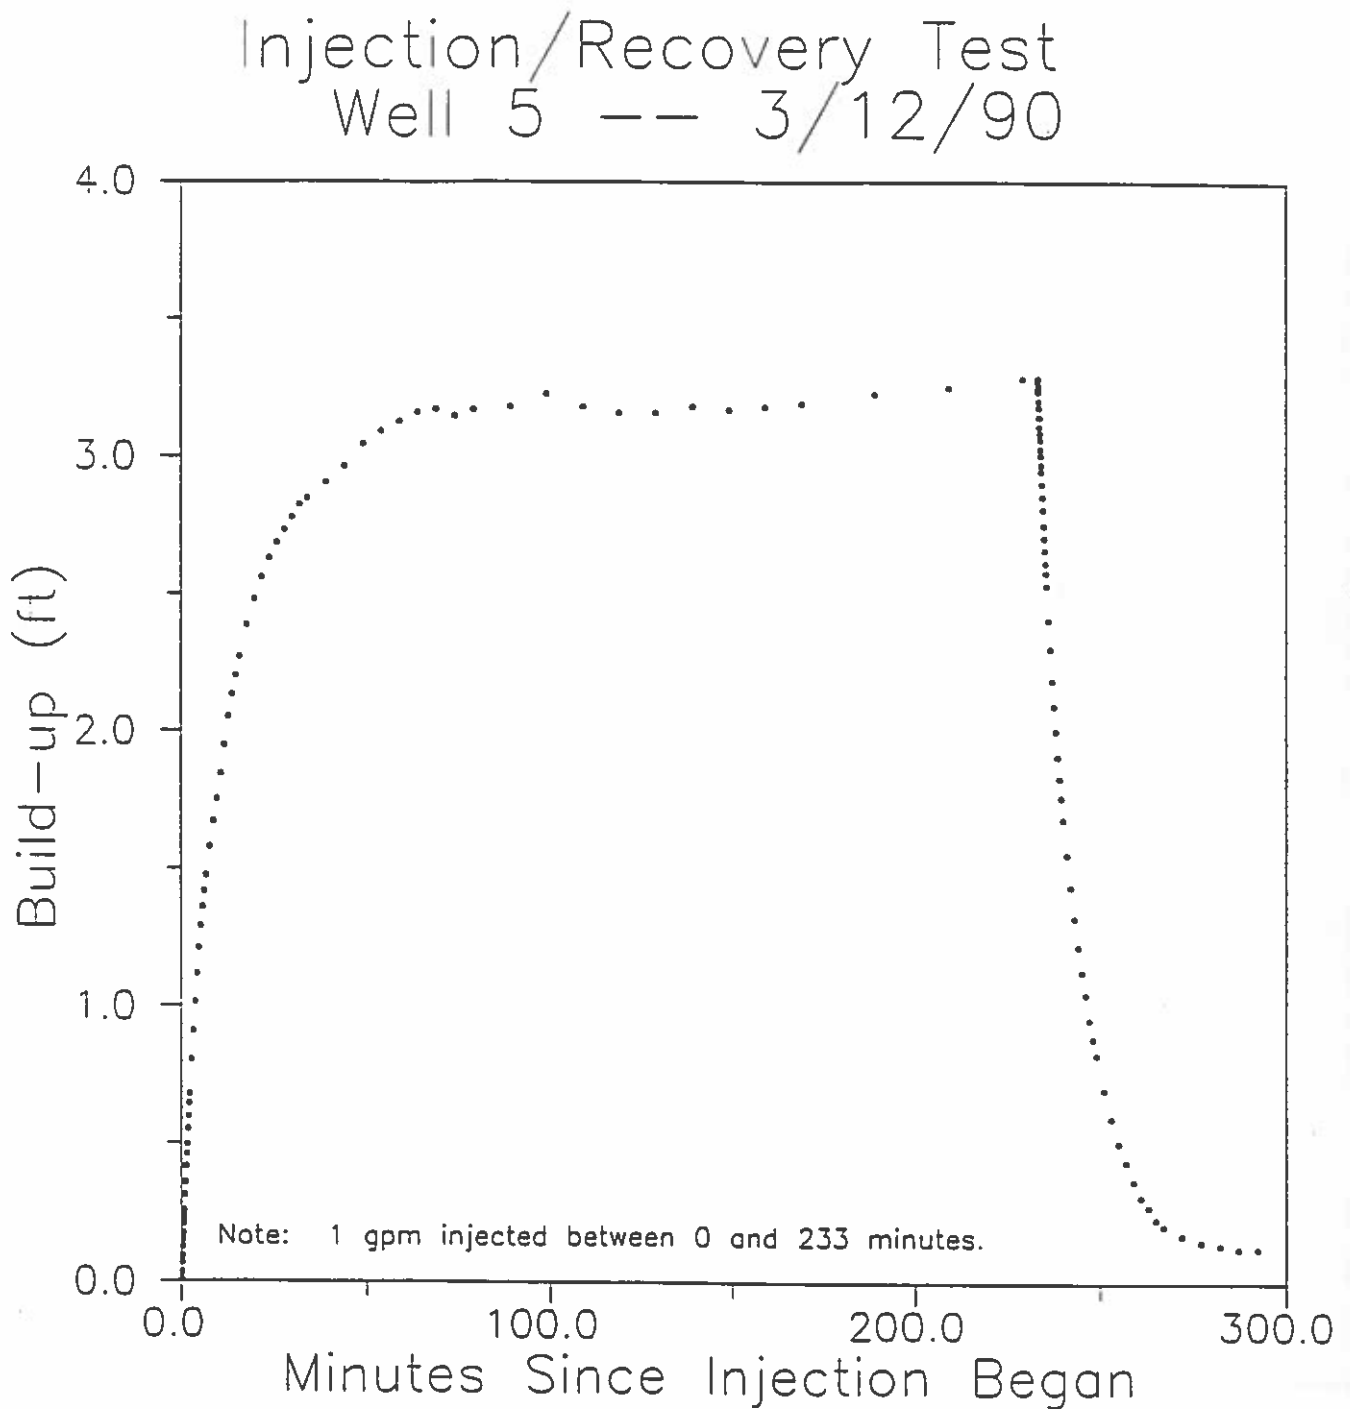
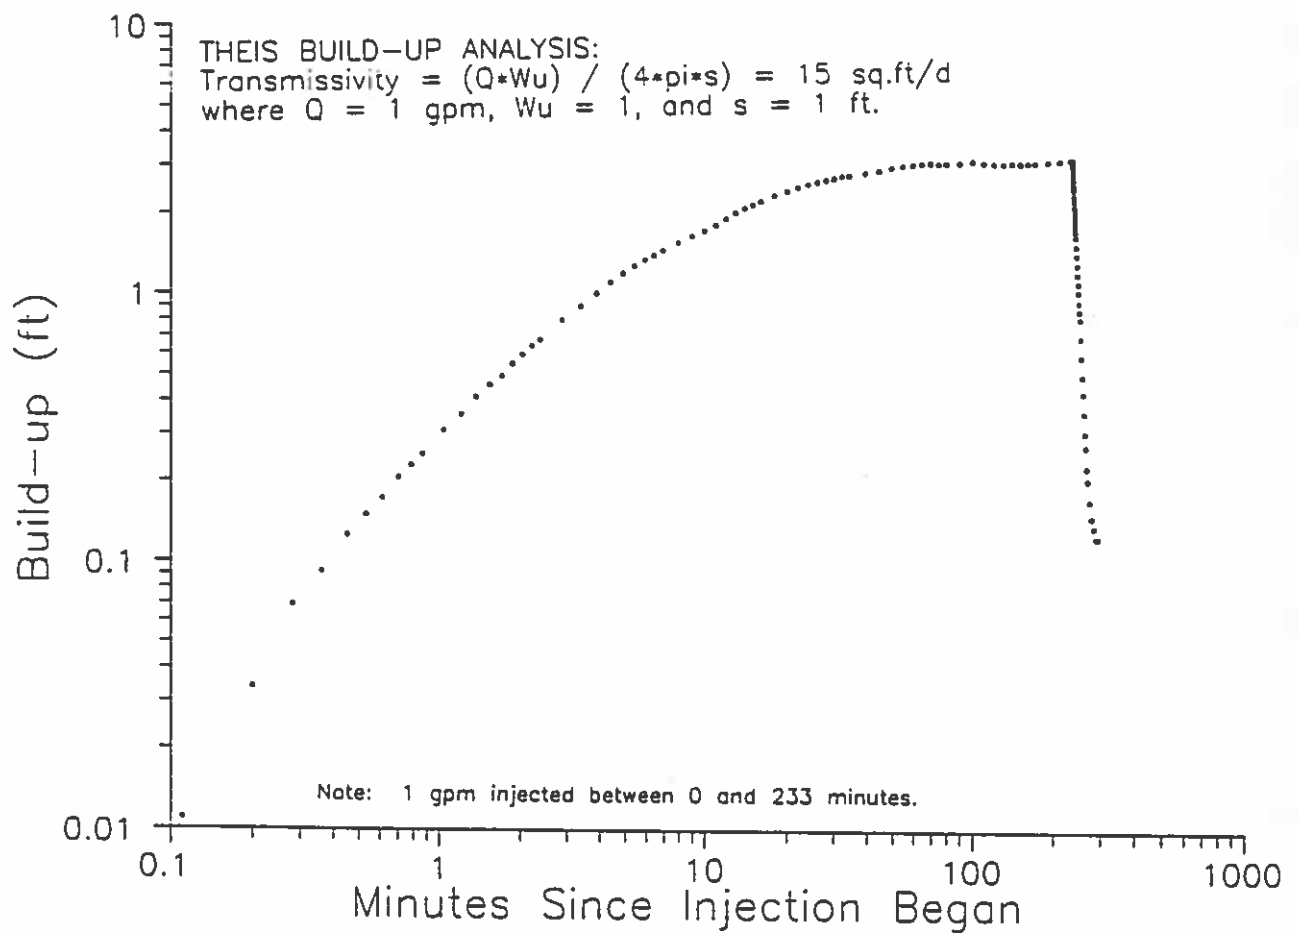
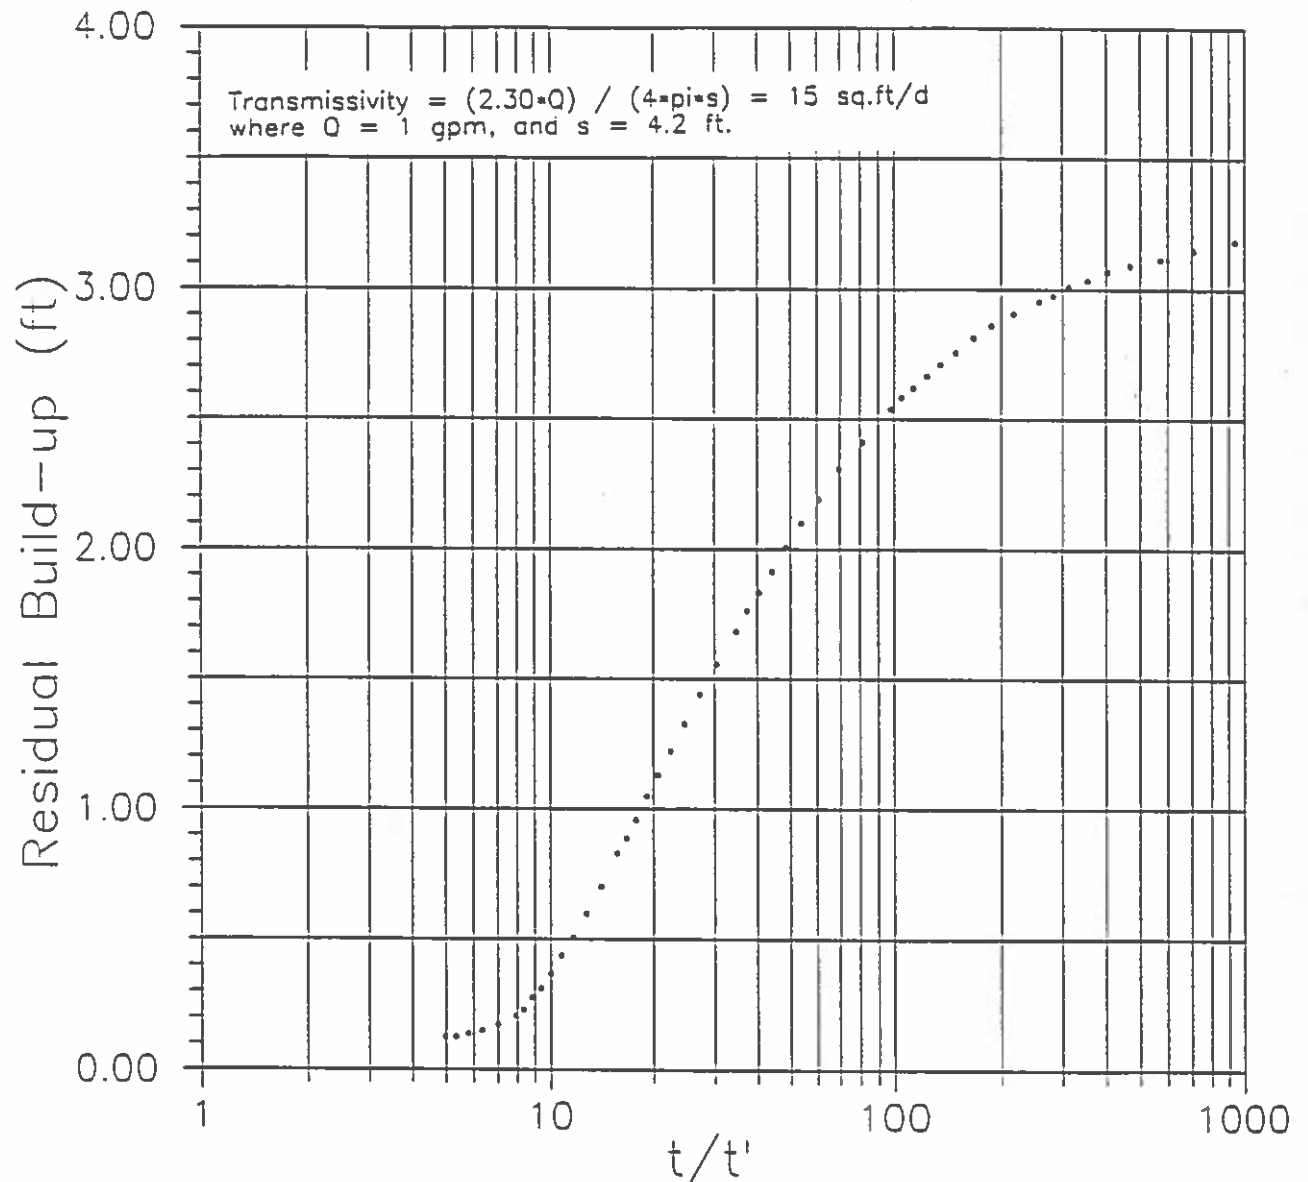
Figure 4.20a. Pumping test results at well MW-5.

Figure 4.20b. Pumping test results at well MW-5.

Figure 4.20c. Pumping test results at well MW-5.

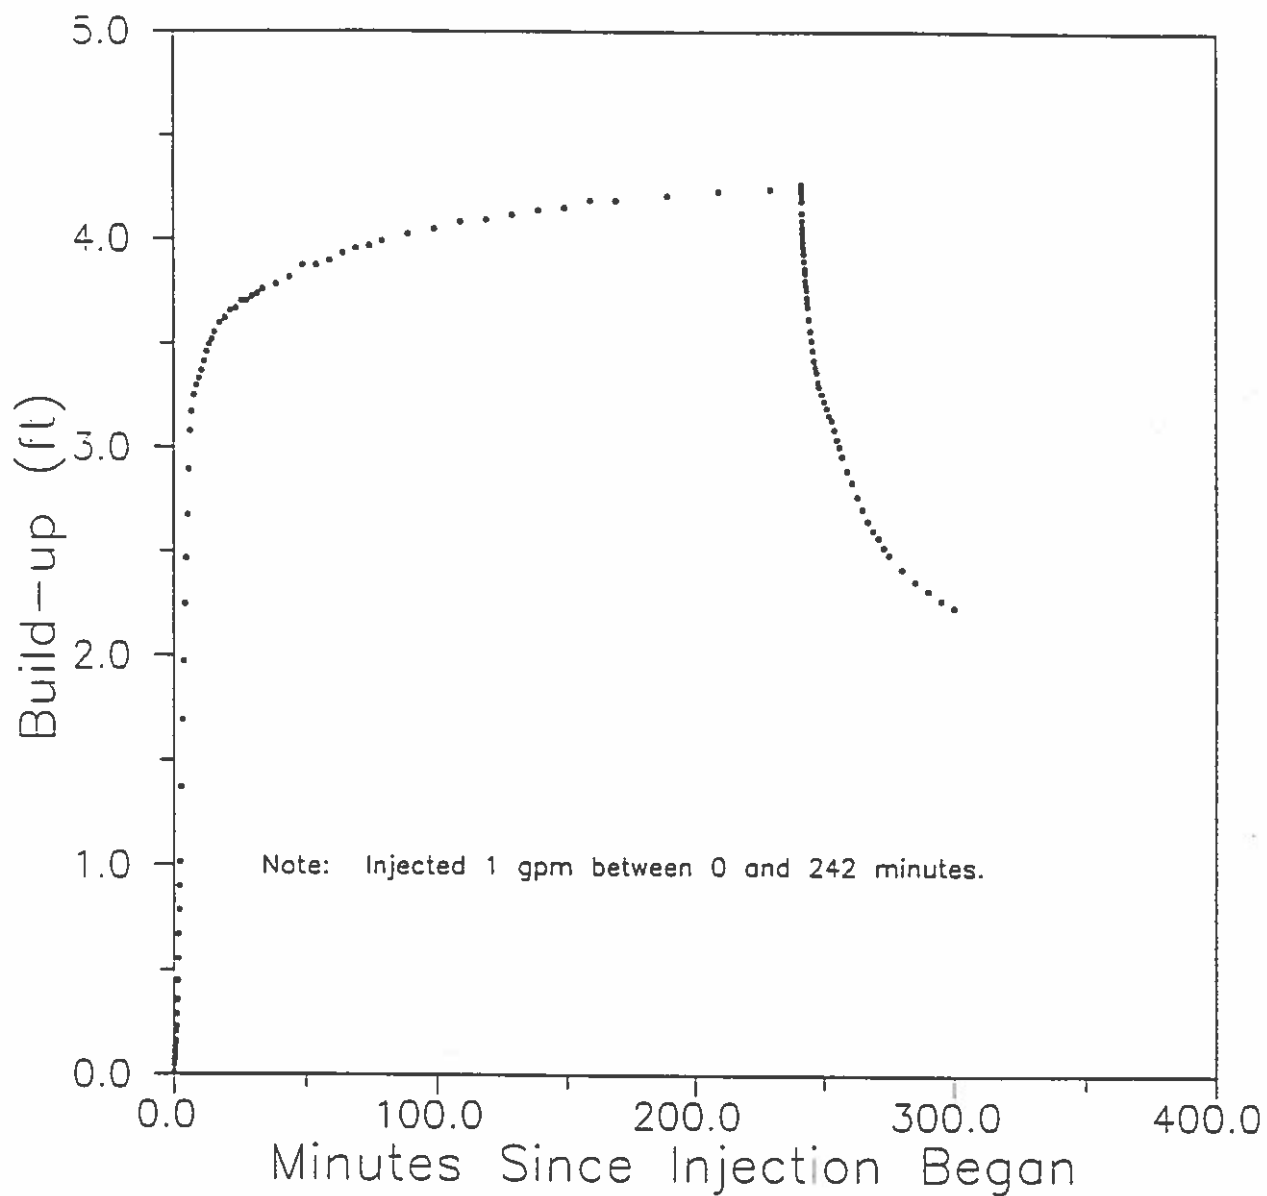
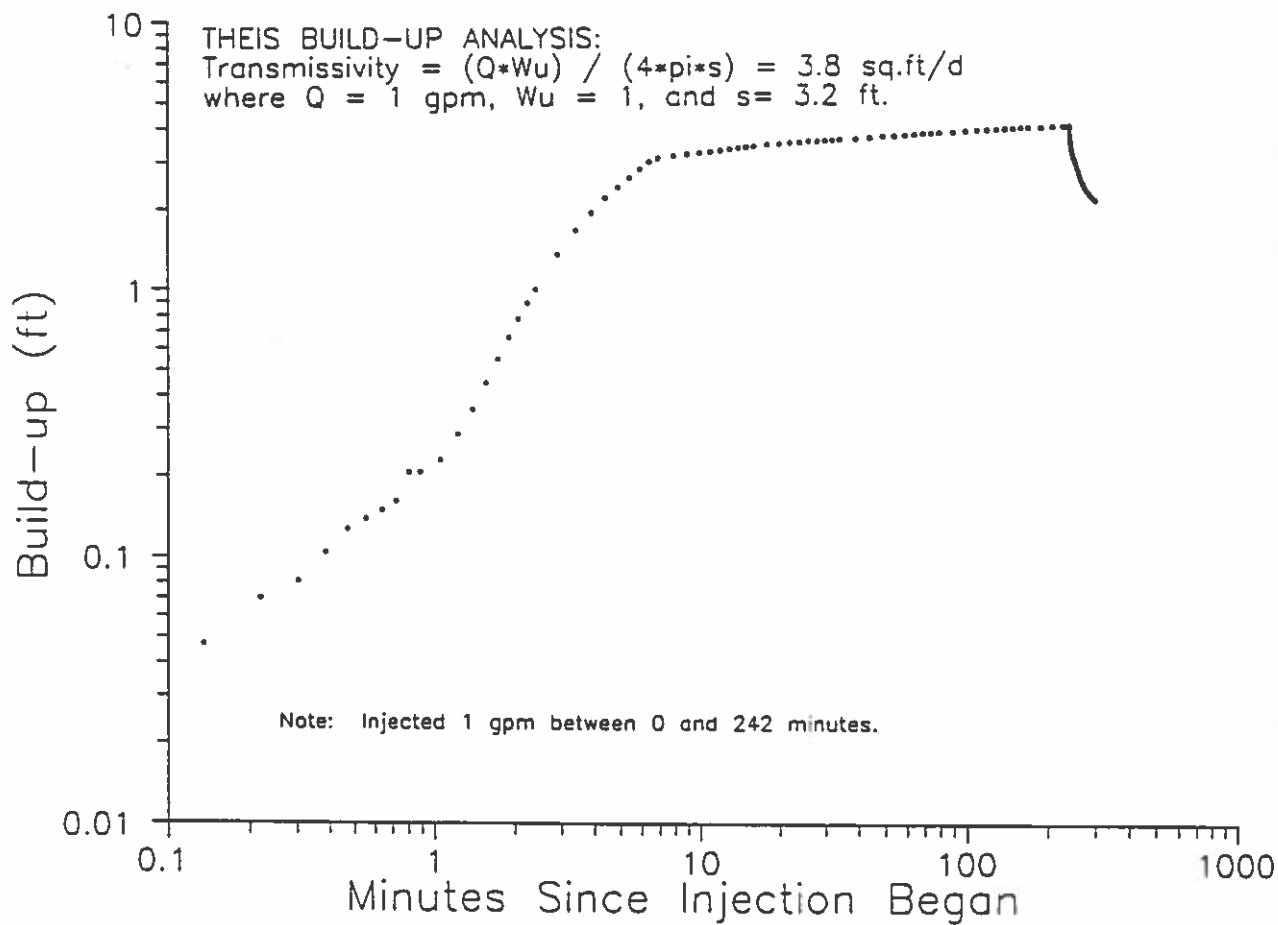
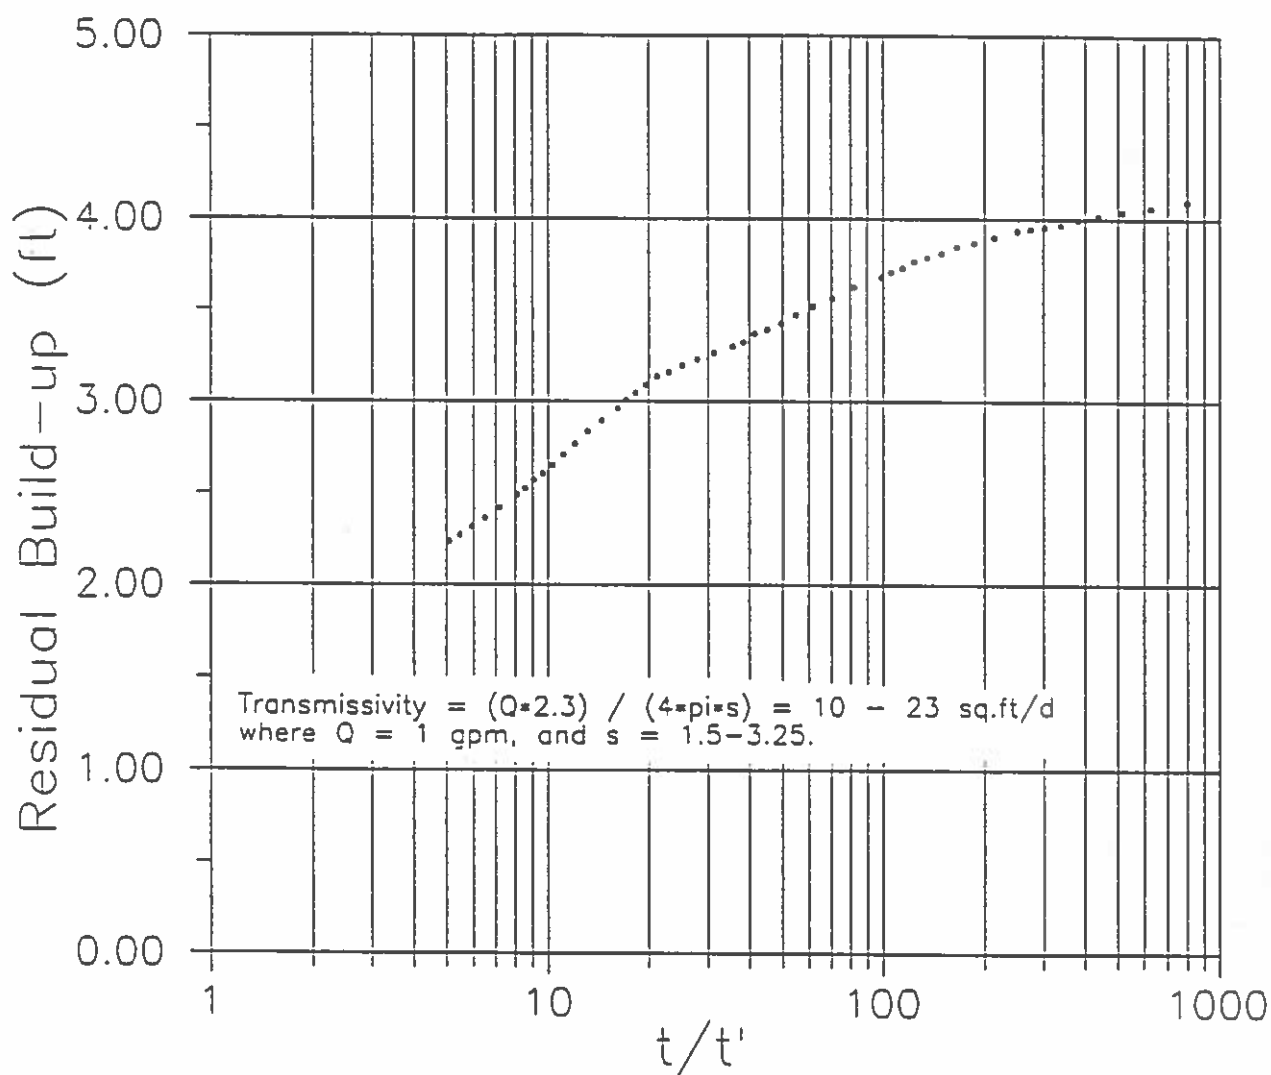
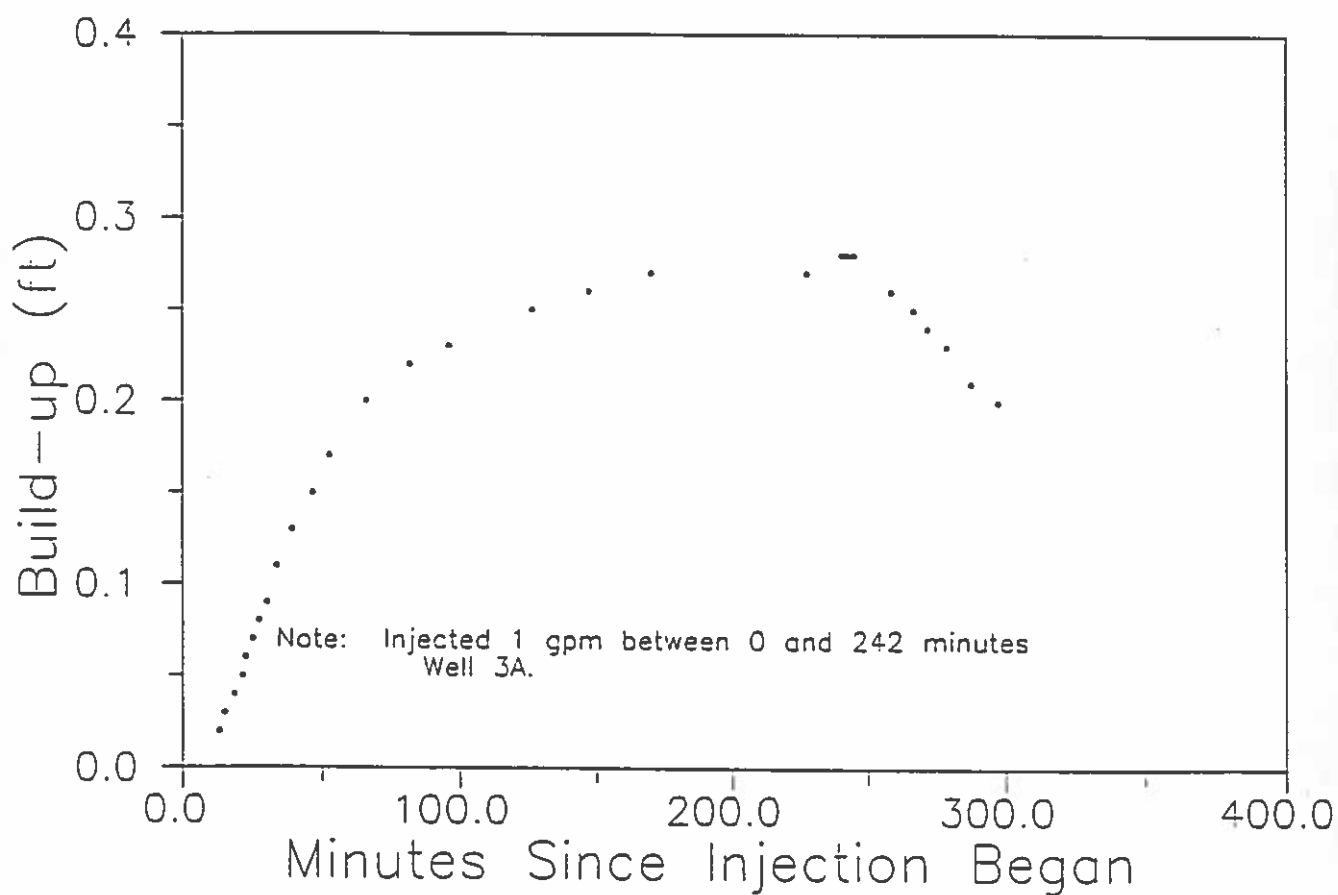
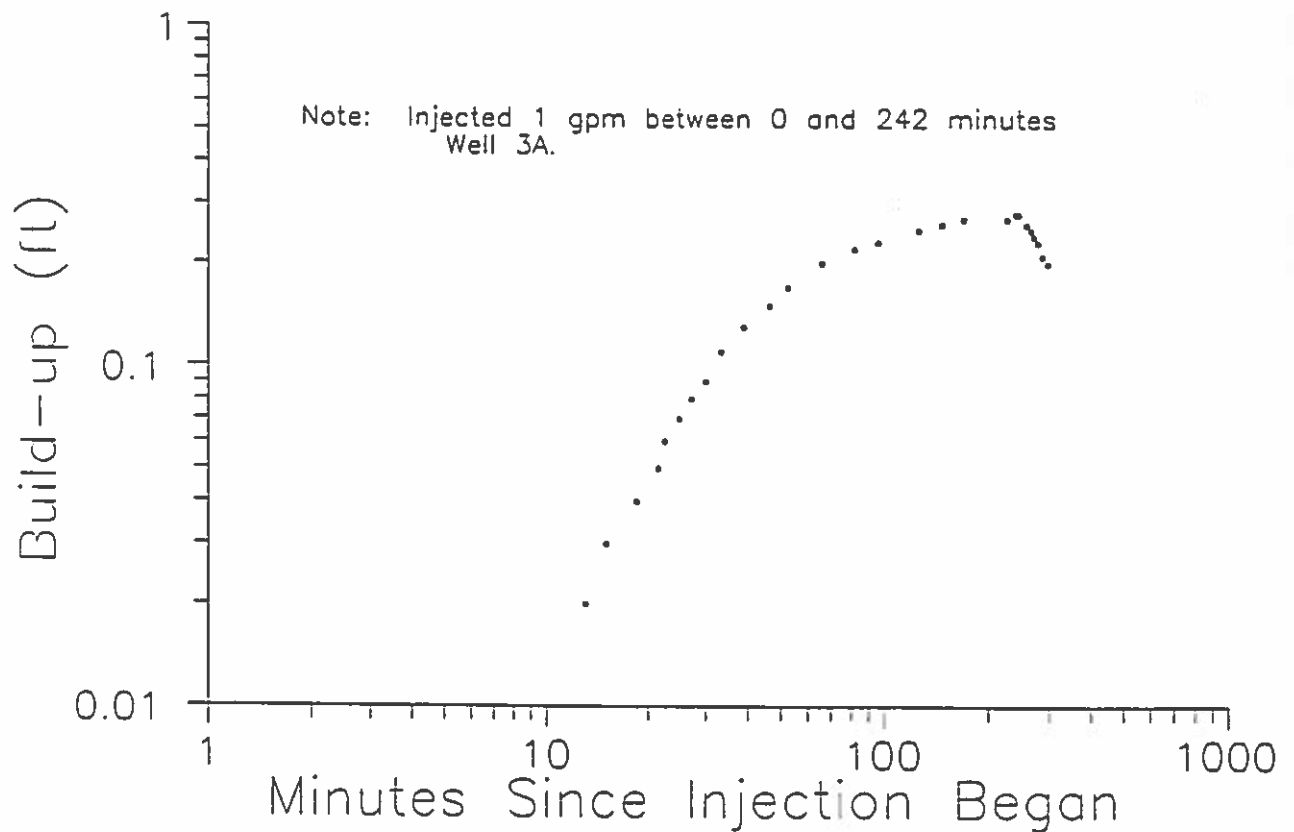
Figure 4.21a. Pumping test results at well MW-3A.

Figure 4.21b. Pumping test results at well MW-3A.

Figure 4.21c. Pumping test results at well MW-3A.

Figure 4.21d. Pumping test results at well MW-3A.

Figure 4.21e. Pumping test results at well MW-3A.

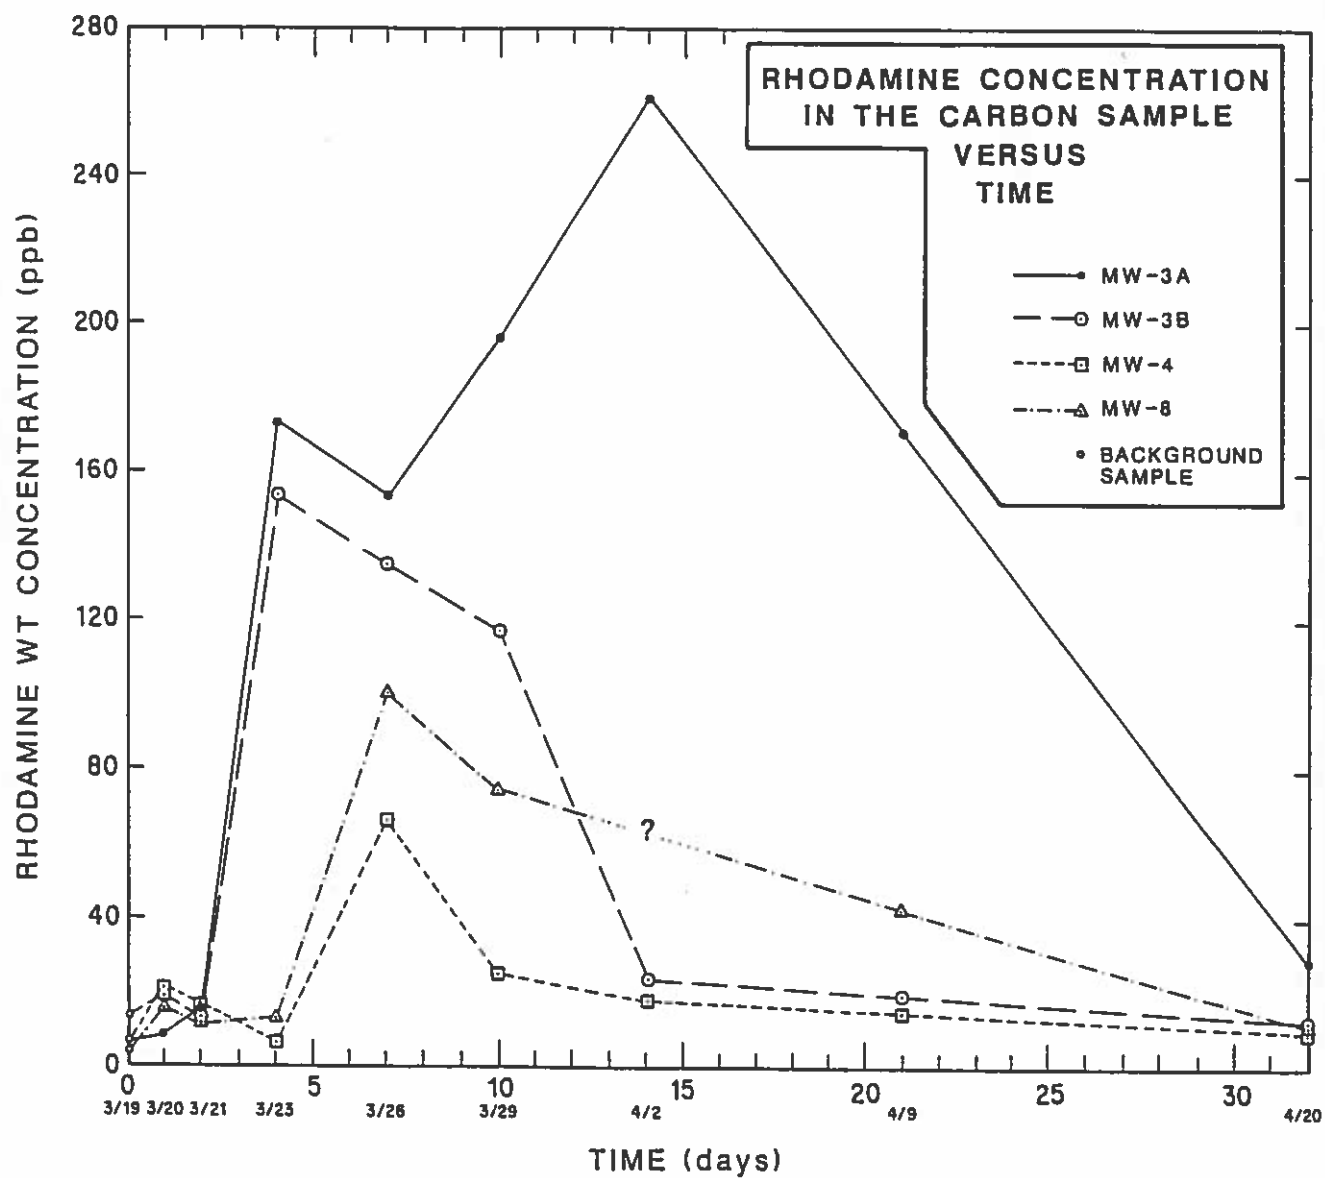
Figure 4.23. Tracer study results for carbon samples at monitor wells.

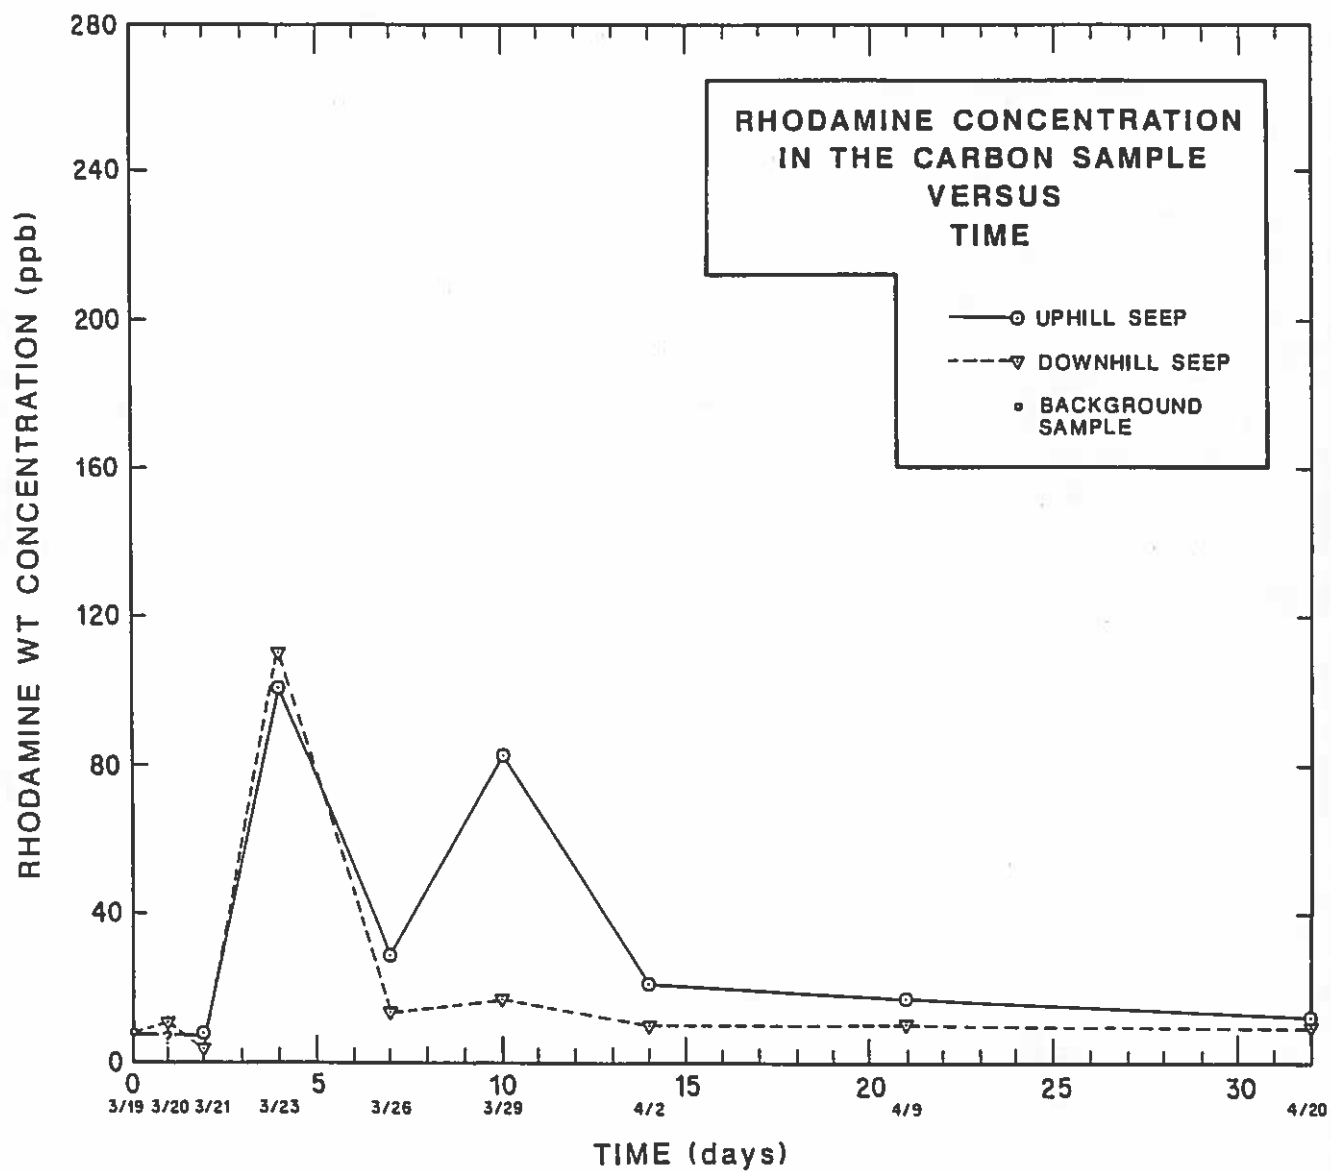
Figure 4.24. Tracer study results at groundwater seeps.
